## Little Colorado-San Juan Watershed

## LITTLE COLORADO - SAN JUAN WATERSHED CHARACTERISTICS

## Little Colorado-San Juan Watershed Assessment Discussion

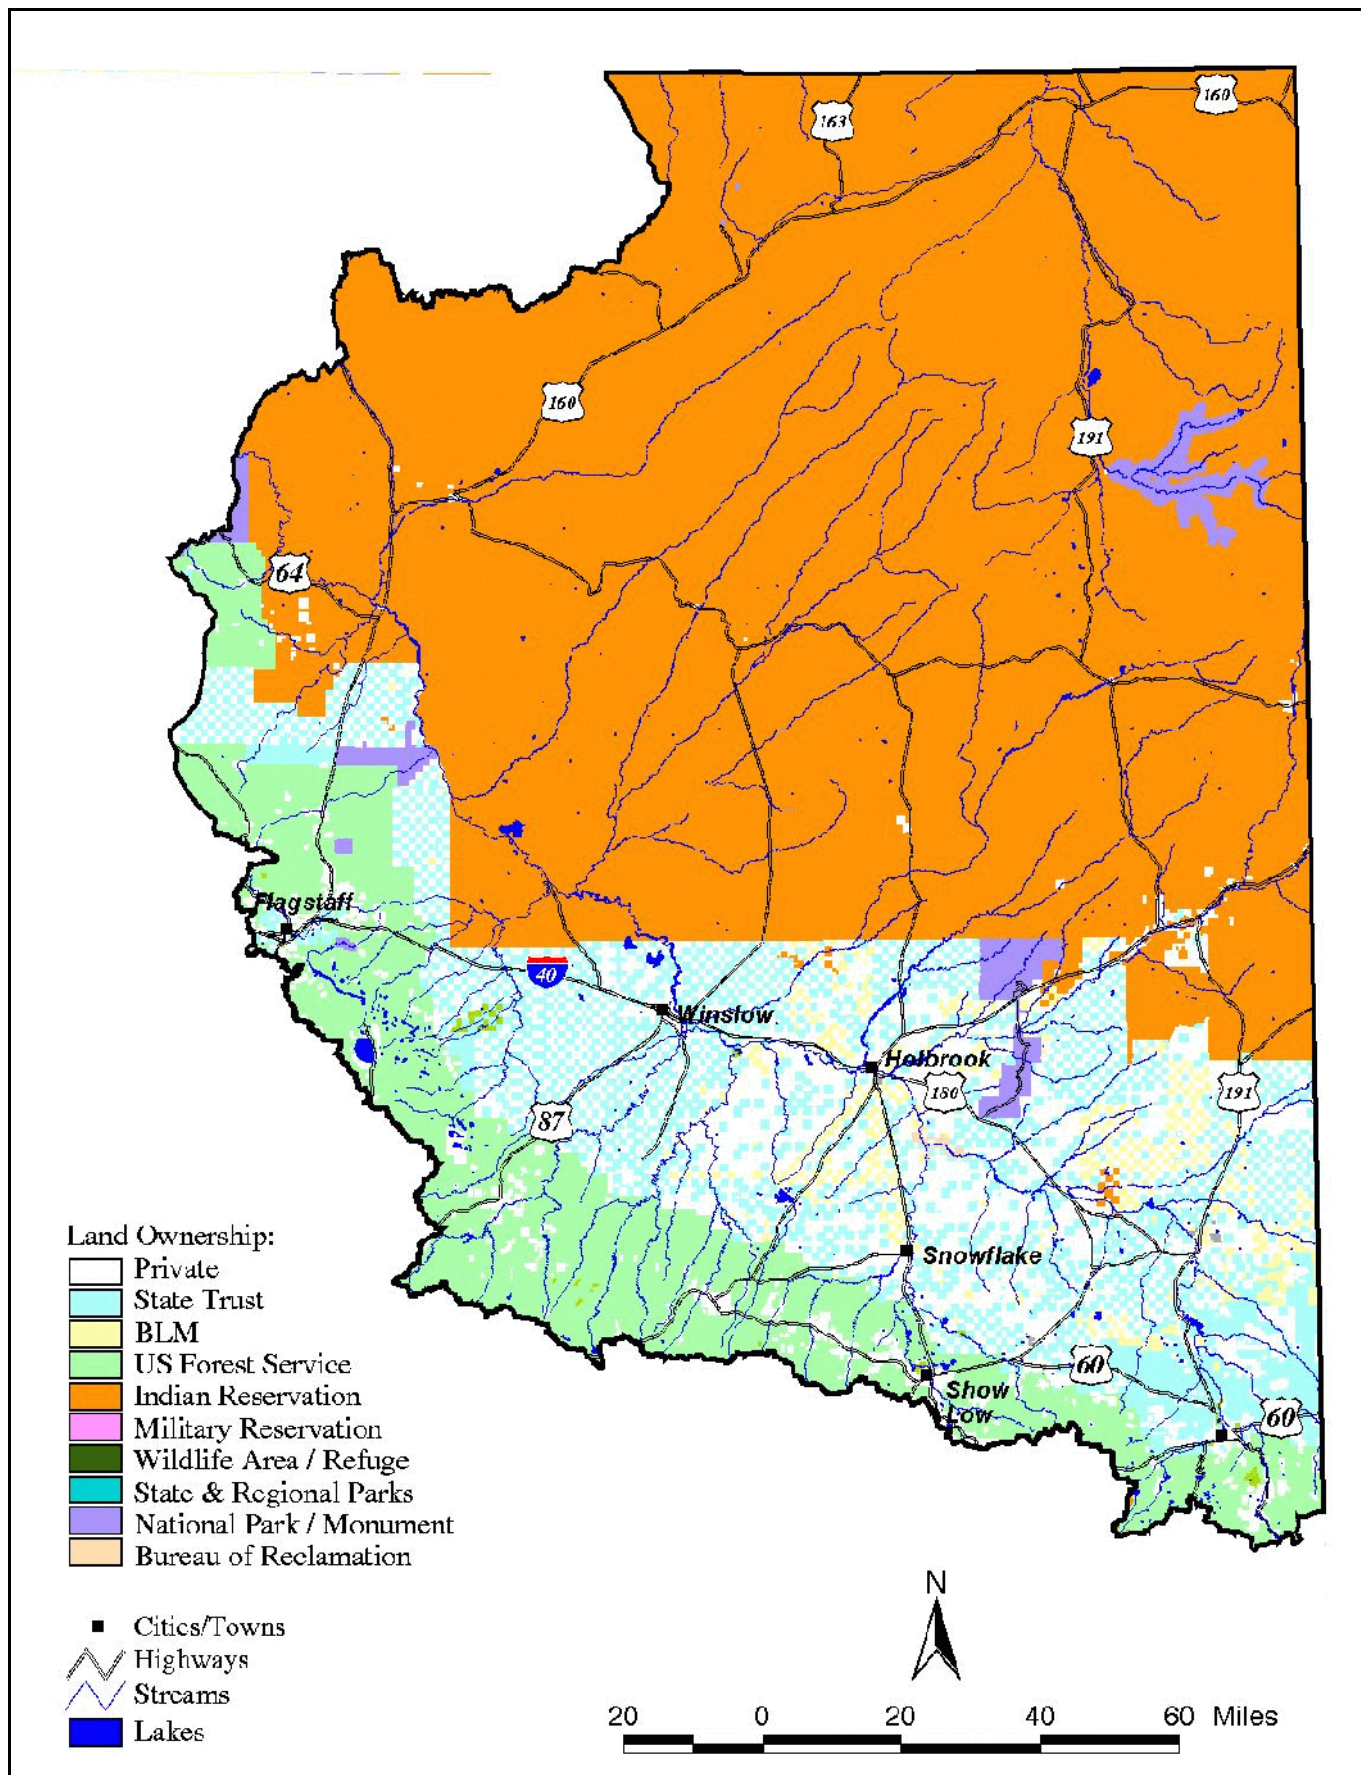
**Figure 21. Land Ownership in the Little Colorado-San Juan Watershed**

SIZE	26,794 square miles (24% of the State's land area).					
POPULATION BASE	Approximately 236,500 people live in this watershed (estimated from the 2000 census). This is about 5% of the state's population.					
LAND OWNERSHIP (Figure 21)	Tribal land	58%	Private land	16%	US Forest Service	11%
	State land	8%	Other state and federal land	3.5%	Bureau of Land Management	2%
	National Parks and Monuments	1.5%				
LAND USES AND PERMITS (Figure 22)	Flagstaff is the largest community in this watershed. Land use on the non-tribal lands outside of Flagstaff is primarily open grazing, forestry, recreation, and mining. Major communities, tribal land, historic mining, roads and the location of facilities with NPDES discharge permits are illustrated on <b>Figure 22</b> .					
	Land and resource preservation and conservation also occur in this watershed with four national monuments, two national forests, and four designated wilderness areas.

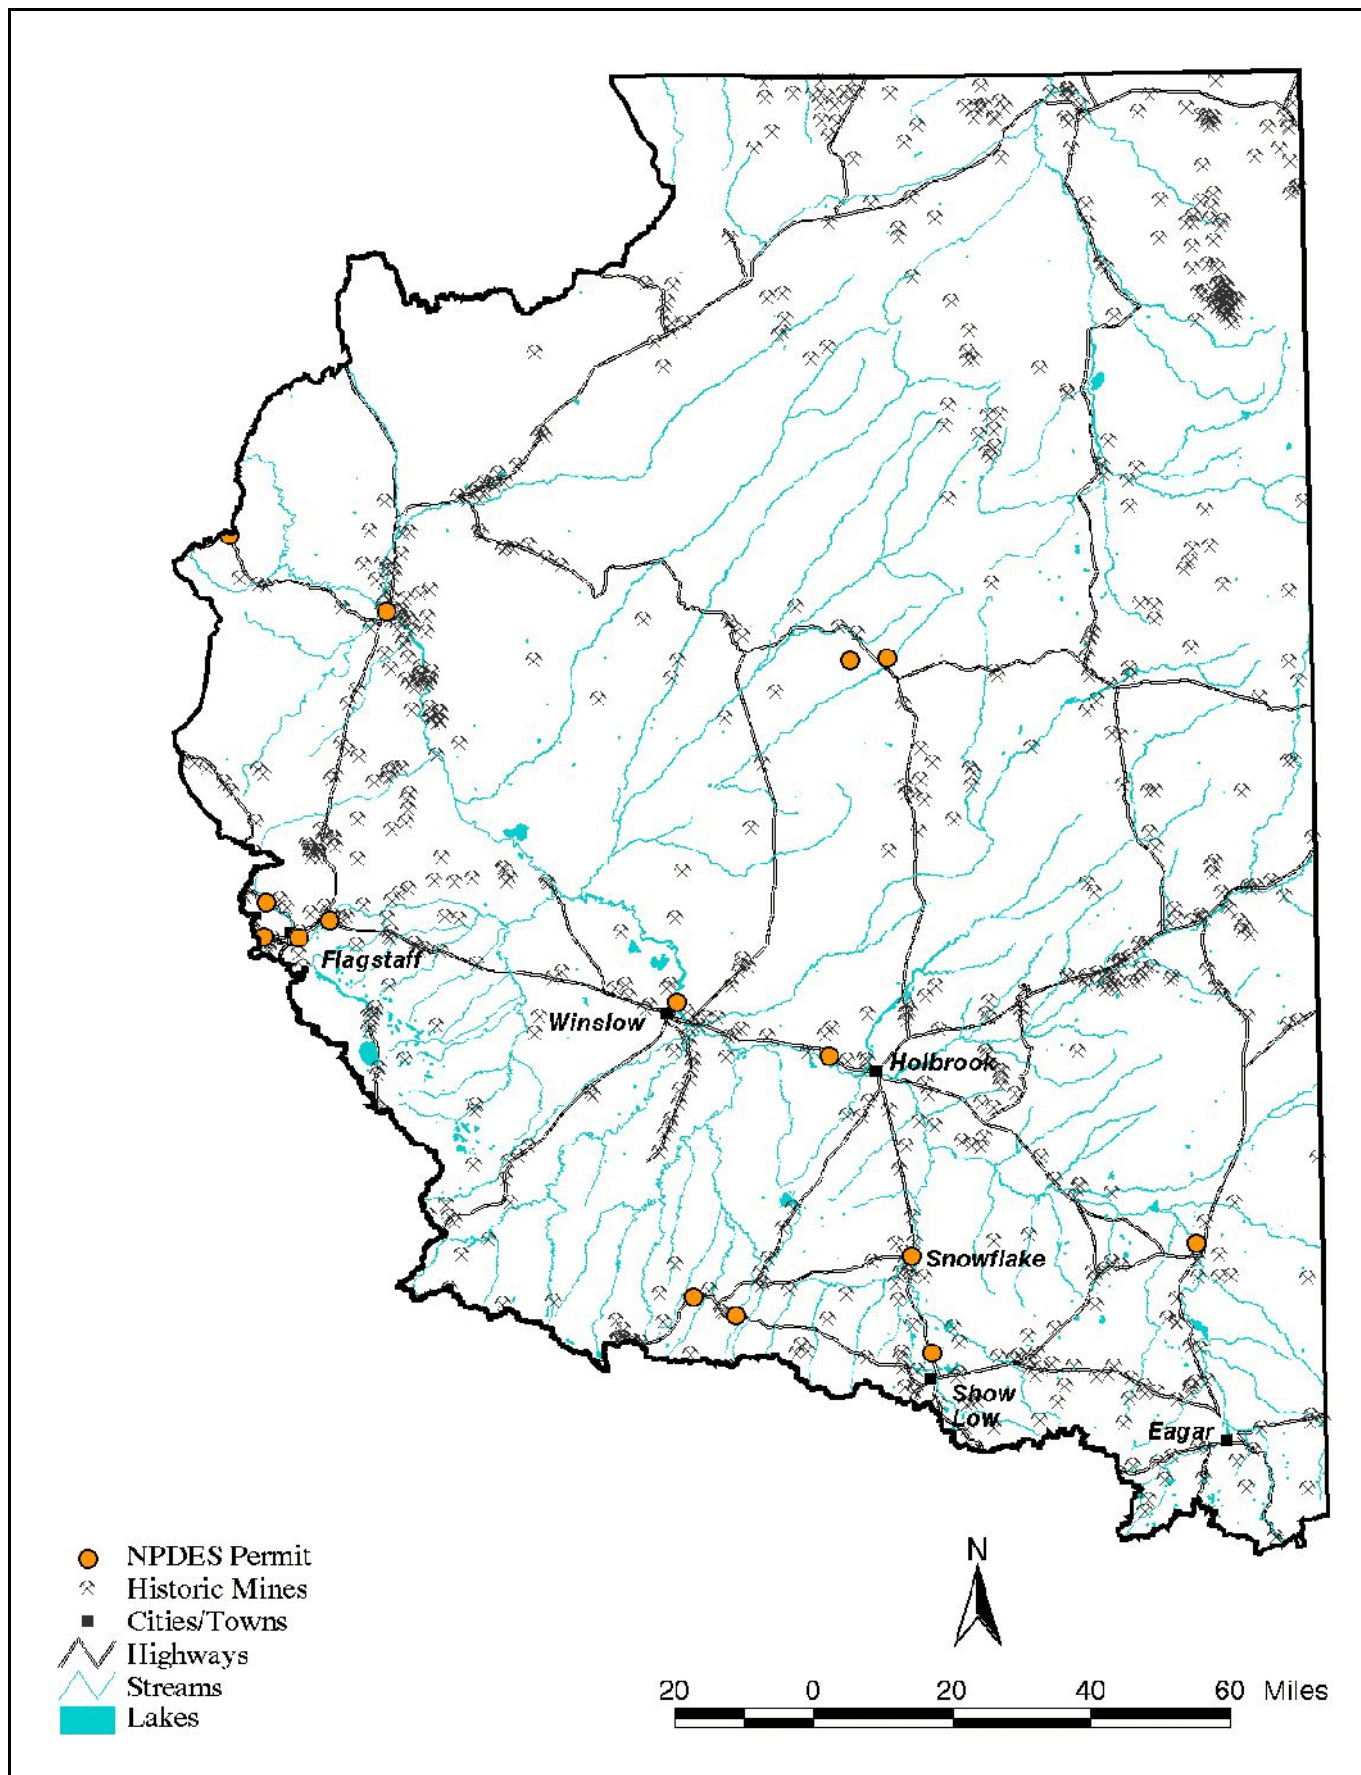
Figure 22. General Land Use and NPDES Permits in the Little Colorado-San Juan Watershed

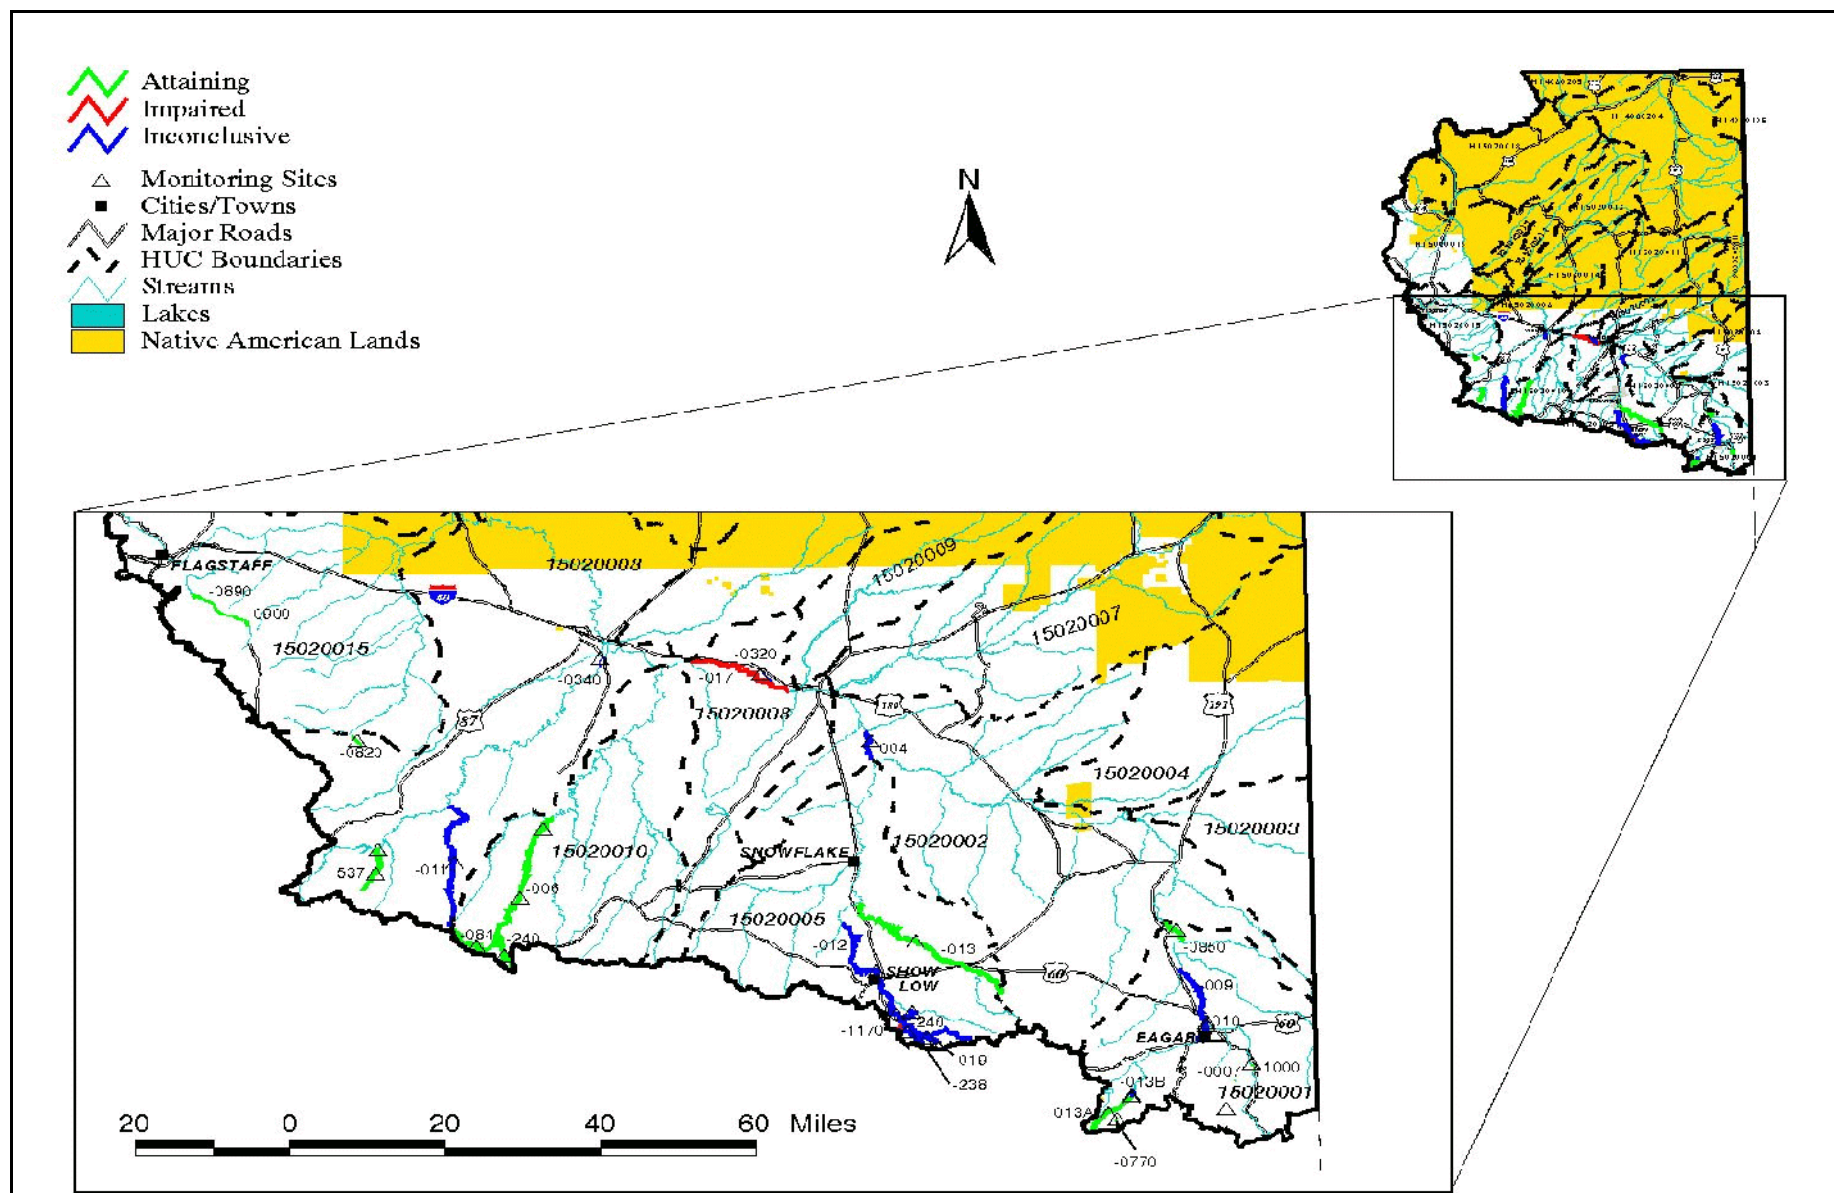
**Figure 23. Little Colorado-San Juan Watershed Surface Water Assessments – 2002**

Water quality assessment information for the Little Colorado-San Juan Watershed is summarized in the following tables and illustrated on **Figure 23**:

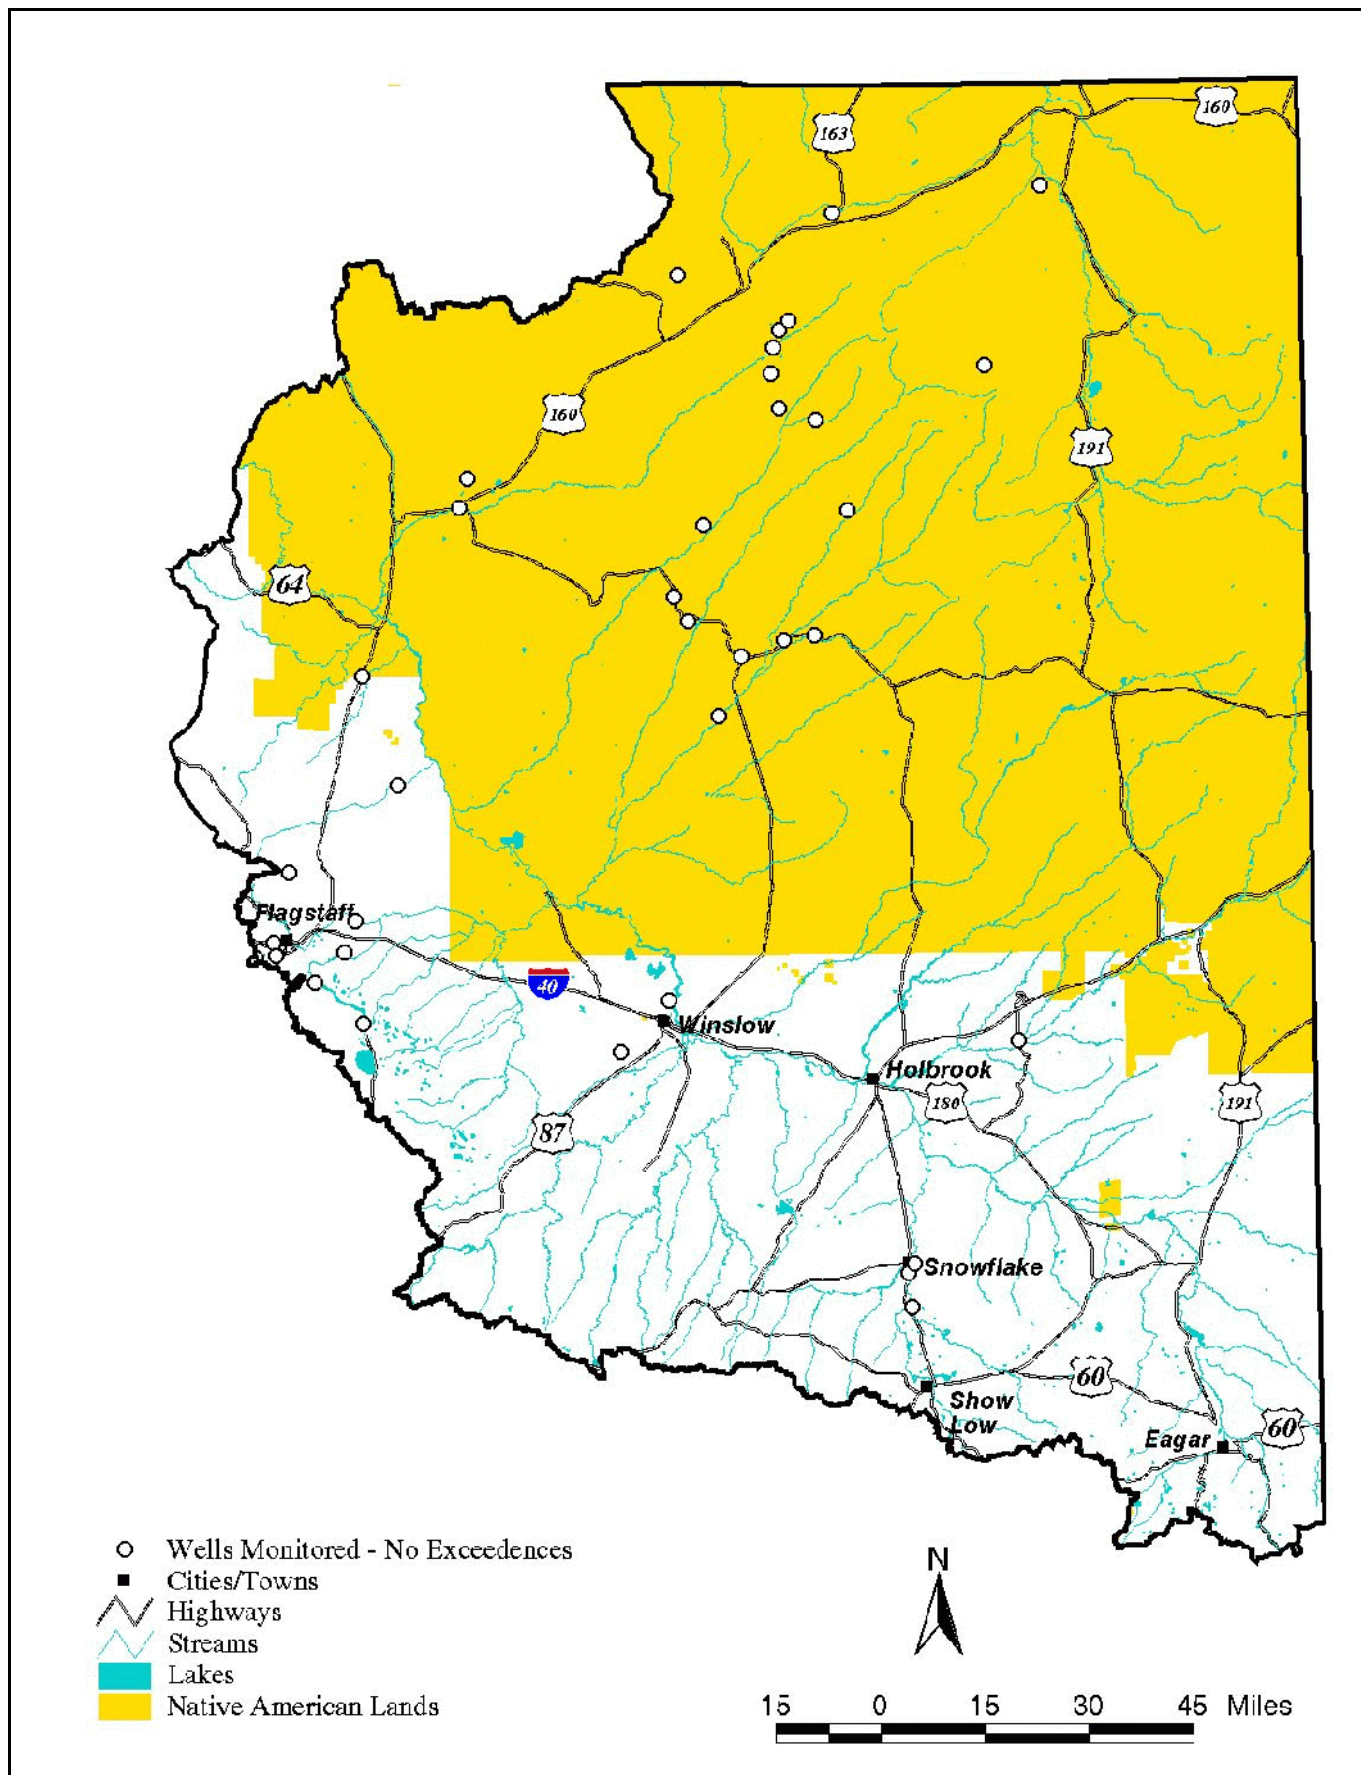
**Figure 24. Ground Water Monitoring in the Little Colorado-San Juan Watershed – 1996-2000**

**Major Ground Water Stressors** – Monitoring data collected from wells in this watershed between October 1995 - October 2000 are summarized in **Table 14** and illustrated in **Figures 24, 25, and 26**. Of the 38 wells monitored, no wells exceeded Aquifer Water Quality Standards. This is a very small number of wells for this large area (**Figure 24**)

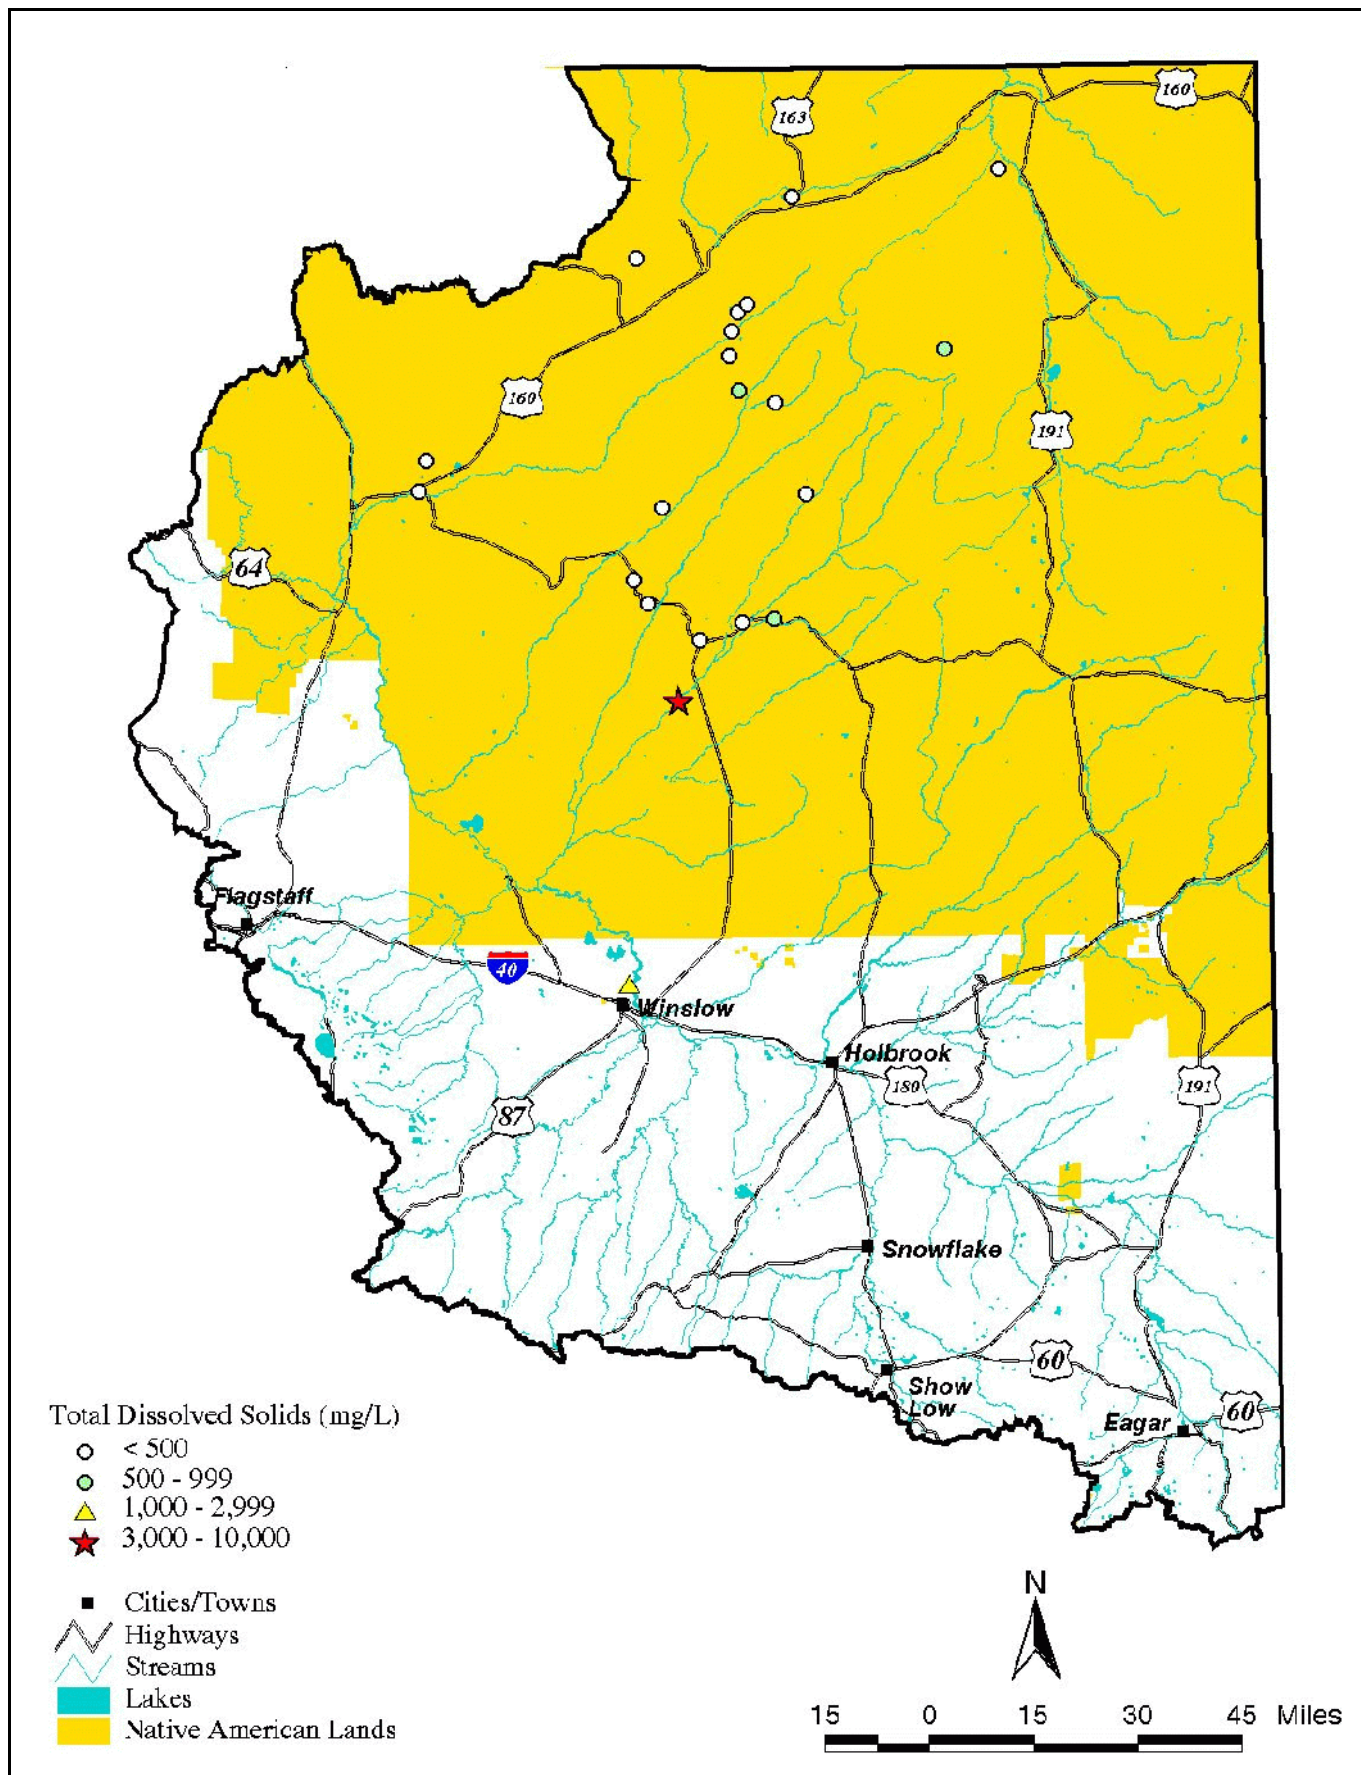
**Figure 25. Ground Water by TDS Concentration in the Little Colorado-San Juan Watershed**

**TDS Concentrations** -- Water quality can be characterized based on concentrations of Total Dissolved Solids (TDS) (**Figure 25**). Elevated salinity may limit practical uses of ground water in some areas as TDS over 500 mg/L has an off-flavor (6 of the 21 wells sampled)) and TDS over 1000 mg/L will limit its use for some crops (2 of 21 wells sampled).

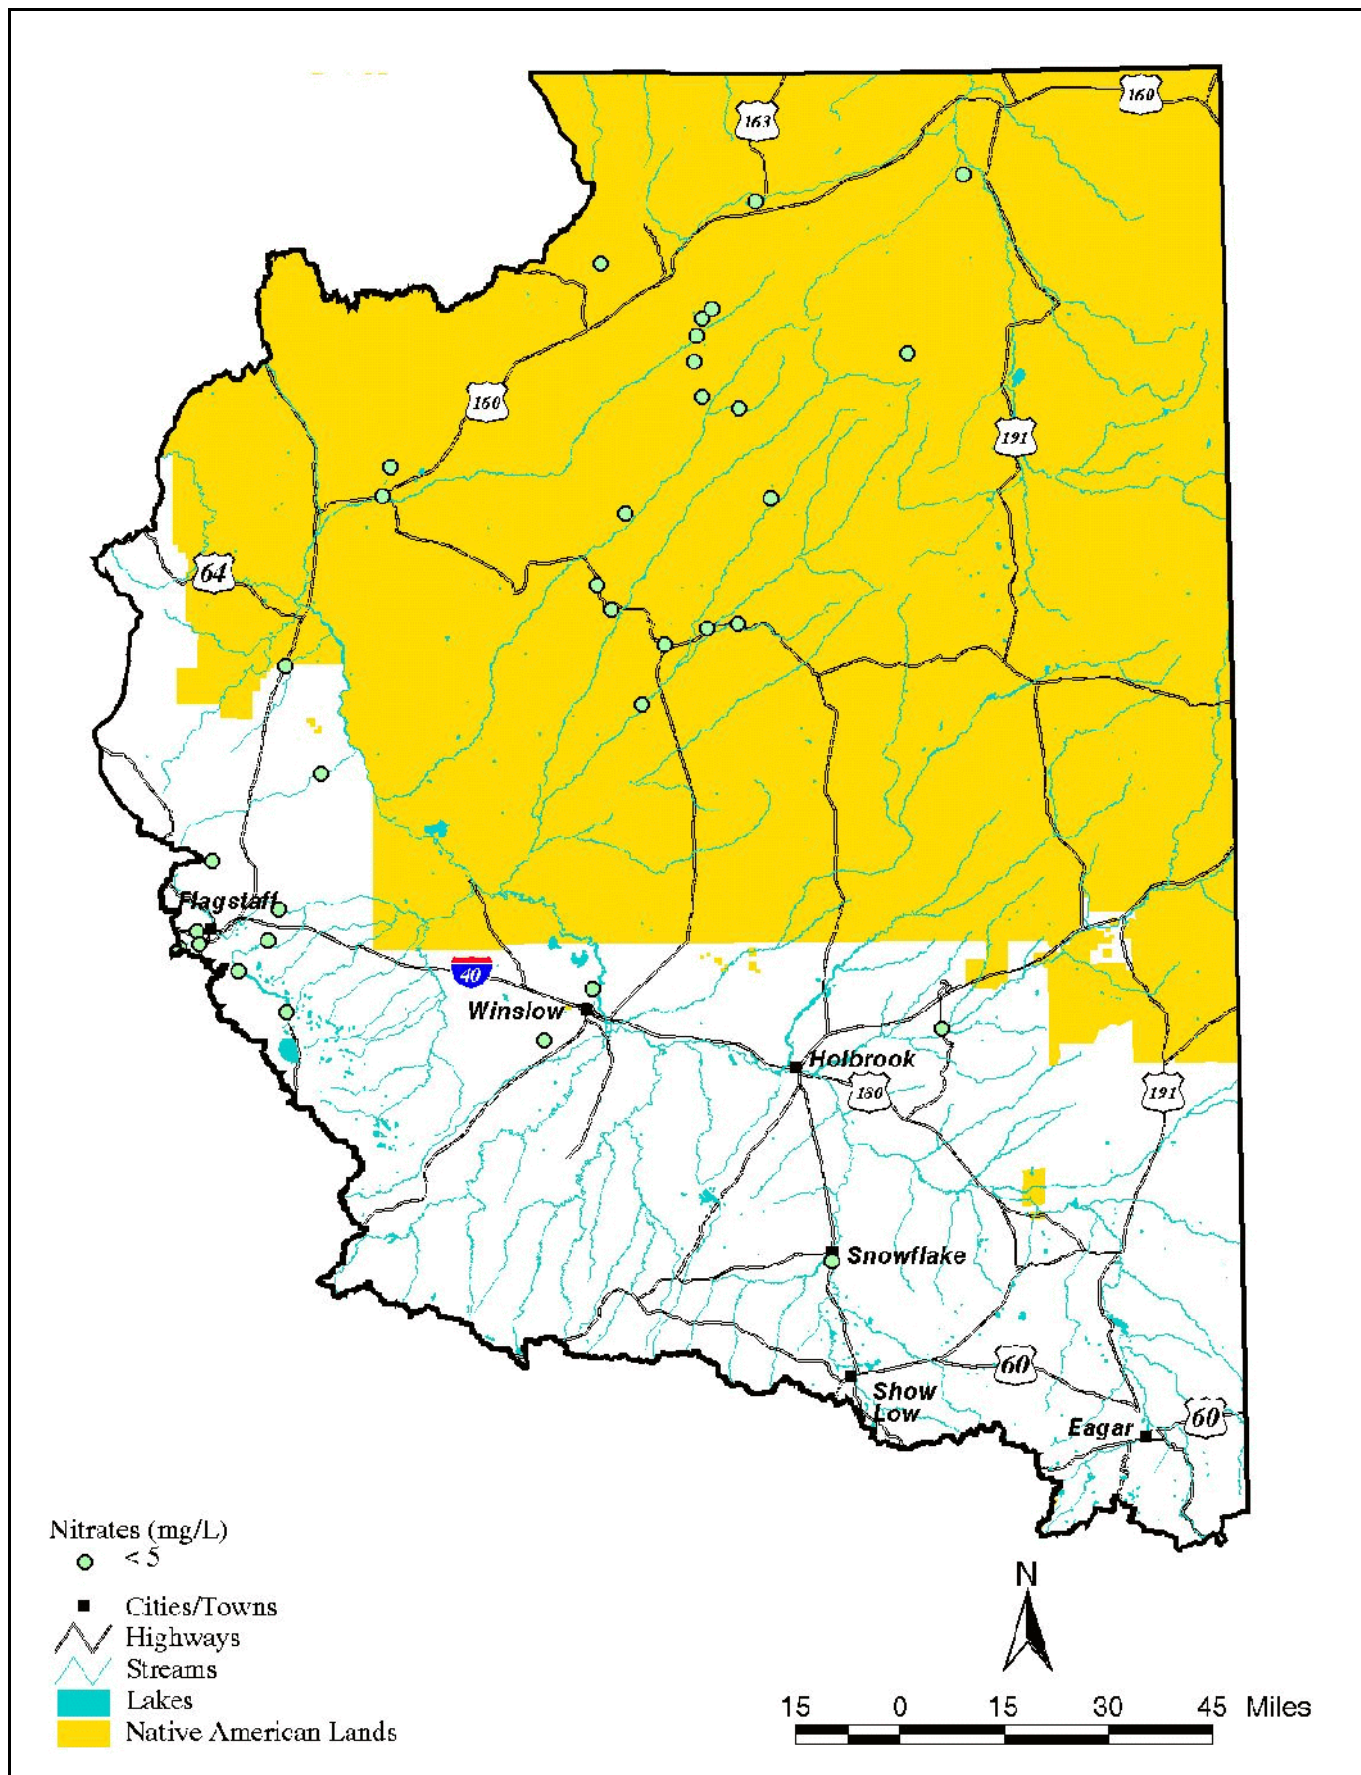
**Figure 26. Ground Water Quality by Nitrate Concentrations in the Little Colorado-San Juan Watershed**

**Nitrate Concentrations** – Water quality can also be characterized by looking at the concentration of nitrates in ground water (**Figure 26**). In Arizona, naturally occurring nitrate concentrations in ground water are generally below 3 mg/L and concentrations above 5 mg/L may indicate potential anthropogenic sources of nitrate. Among the 36 wells monitored, all nitrate concentrations were below 5 mg/L, indicating high quality water.
